DOT/FAA/82-156

FIRE CONTAINMENT CHARACTERISTICS OF AIRCRAFT CLASS D CARGO COMPARTMENTS

David R. Blake
Richard G. Hill

Final Report

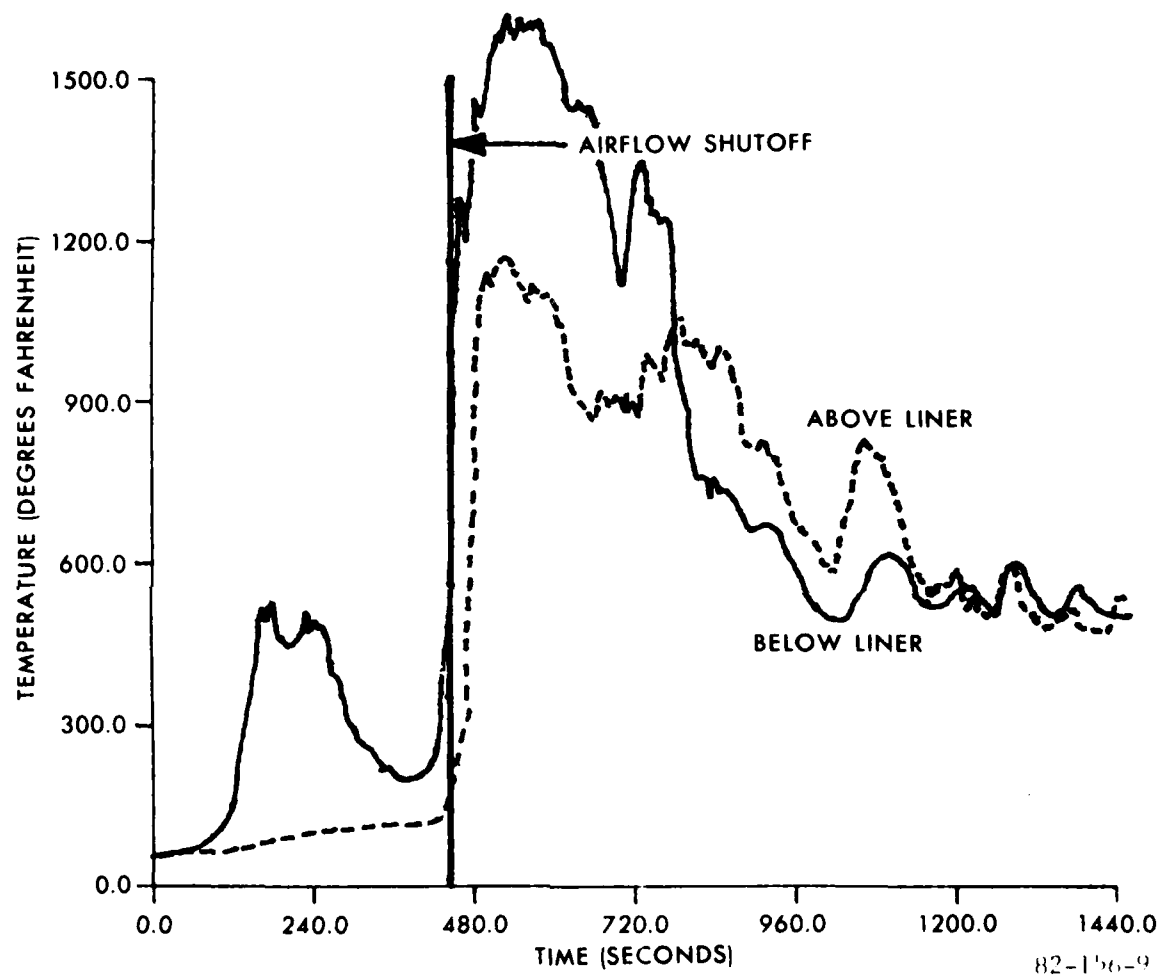
FIGURE 8. TEMPERATURE ABOVE AND BELOW NOMEX™ LINER

Four tests were conducted with Nomex™ ceiling liners. For reasons unrelated to the study, no fire resulted in the first test. The fire penetrated the Nomex™ ceiling liner in the remaining three tests. Burnthrough occurred zero to forty seconds after smoke detector activation. Figure 7 shows the damage to the Nomex™ liner after test 2. The fire intensity cycled noticeably in tests 2 and 10. As the oxygen was consumed the fire subsided, allowing the oxygen level to rise again due to entrained air. When it reached a critical level, rapid burning of the combustible material resumed. Overpressurization of the compartment resulted from this rapid burning and forced smoke back against the flow of above-ceiling air and out the inlet. In an aircraft this would be analogous to smoke being forced into the pressurized cabin instead of out the overboard vents. This occurred three or four times during tests 2 and 10 (figure 7).

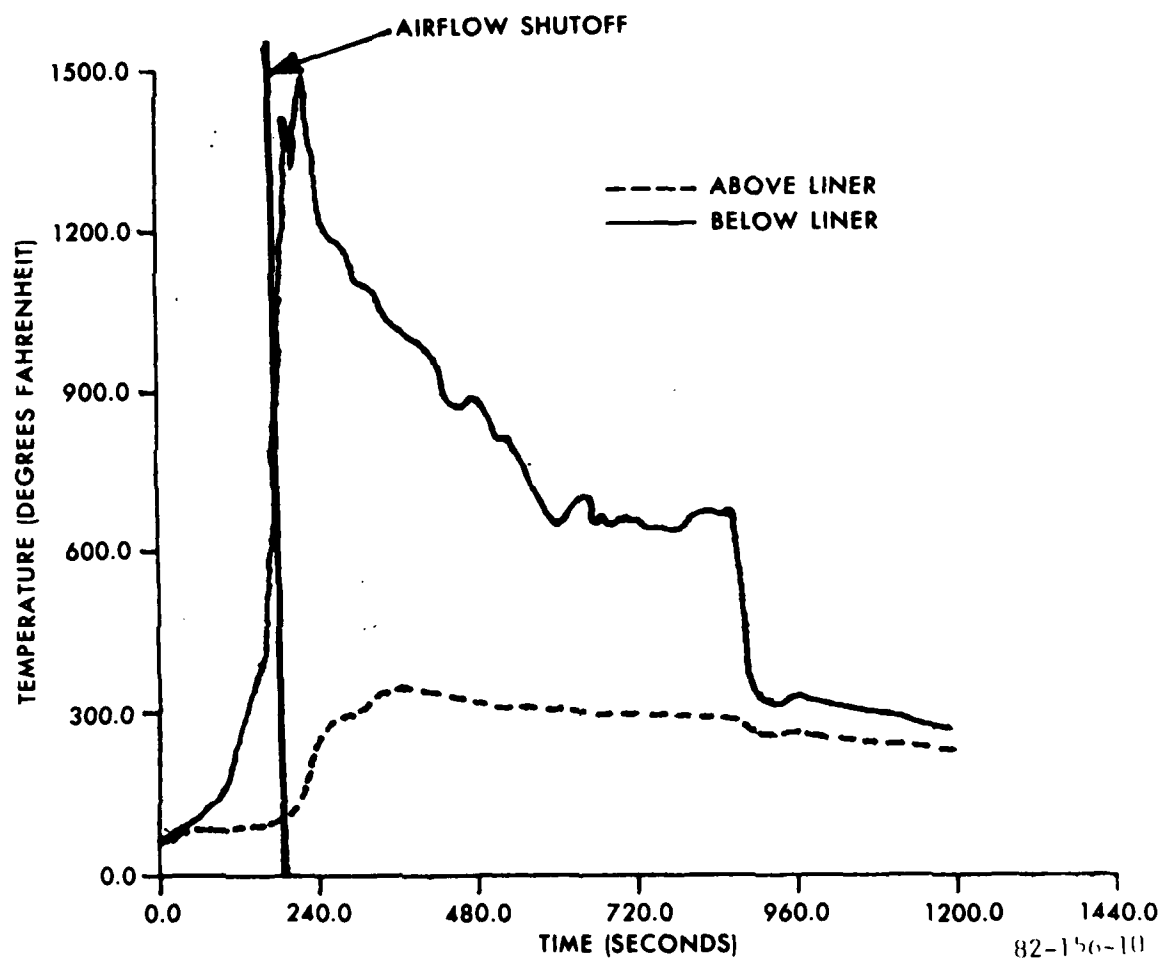
FIGURE 9. TEMPERATURE ABOVE AND BELOW FIBERGLASS LINER

Three tests were conducted using a fiberglass ceiling liner. Cargo compartment temperatures similar to the tests with the Nomex liner resulted, but the fire never burned through the fiberglass liner. However, large quantities of smoke were present above the ceiling. Some of the reasons for smoke collecting above the ceiling were: the burning of the resin on the backface of the fiberglass, the permeable nature of the fiberglass cloth after the resin burned away, and the natural leakage through cracks and joints in the drop ceiling structure. There was no evidence of the cycling of the fire observed in tests 2 and 10. It should be noted that both the Nomex and the fiberglass easily passed the vertical and 45-degree bunsen burner tests required for class D cargo compartment liners. Figures 8 and 9 illustrate the effectiveness of the two different lining materials as a fire barrier. Temperatures above the ceiling liner are compared with those below the liner. Although the below-ceiling temperatures were similar, the temperature above the fiberglass liner never exceeded 400° F, while the temperature above the Nomex liner reached 1150° F. At approximately 800 seconds into the Nomex test, the above ceiling temperature exceeded the temperature below the liner. The Nomex liner no longer existed at this point. Figure 10 is a plot of oxygen concentration versus time for tests 7 and 10. The fiberglass liner was able to maintain an oxygen concentration of less than 10 percent for 10 minutes. While this did not extinguish the fire, it did reduce the initial flare up, resulting in a small fire with very little spread. The oxygen concentration during the Nomex test dropped to a minimum concentration of 10 percent but rose again to 18 percent as the liner burned away and fresh air was entrained.

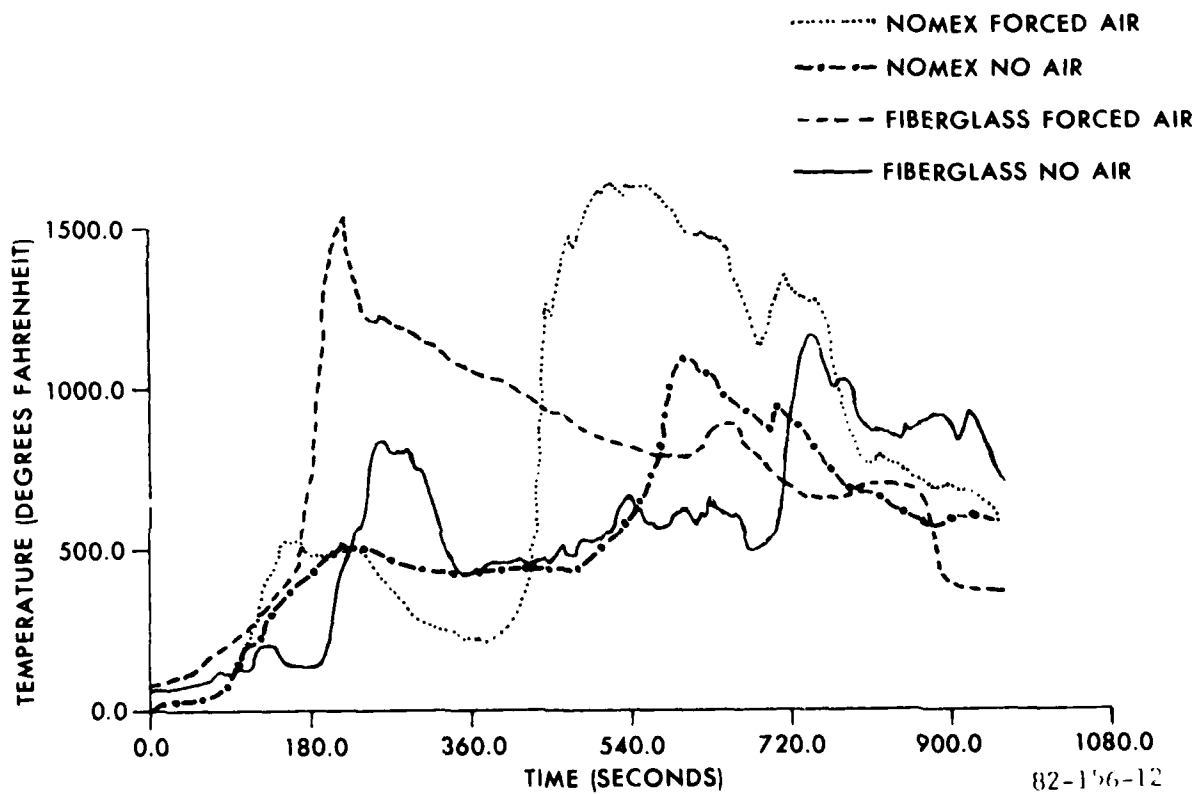
FIGURE 11. BELOW CEILING TEMPERATURES

Figures 11 and 12 show the effect of forced ventilation on fire growth and intensity. The temperature below the ceiling increased earlier and became hotter with both liner types when forced ventilation was used. The most severe fire in terms of above-ceiling temperatures was during test 10 using the Nomex ceiling liner and forced ventilation. Temperatures above the ceiling increased earliest in the test using the fiberglass ceiling liners and forced ventilation but the temperature leveled off before reaching 400° F. The fire in the test using the Nomex liner and no forced ventilation took longer to develop, but eventually reached

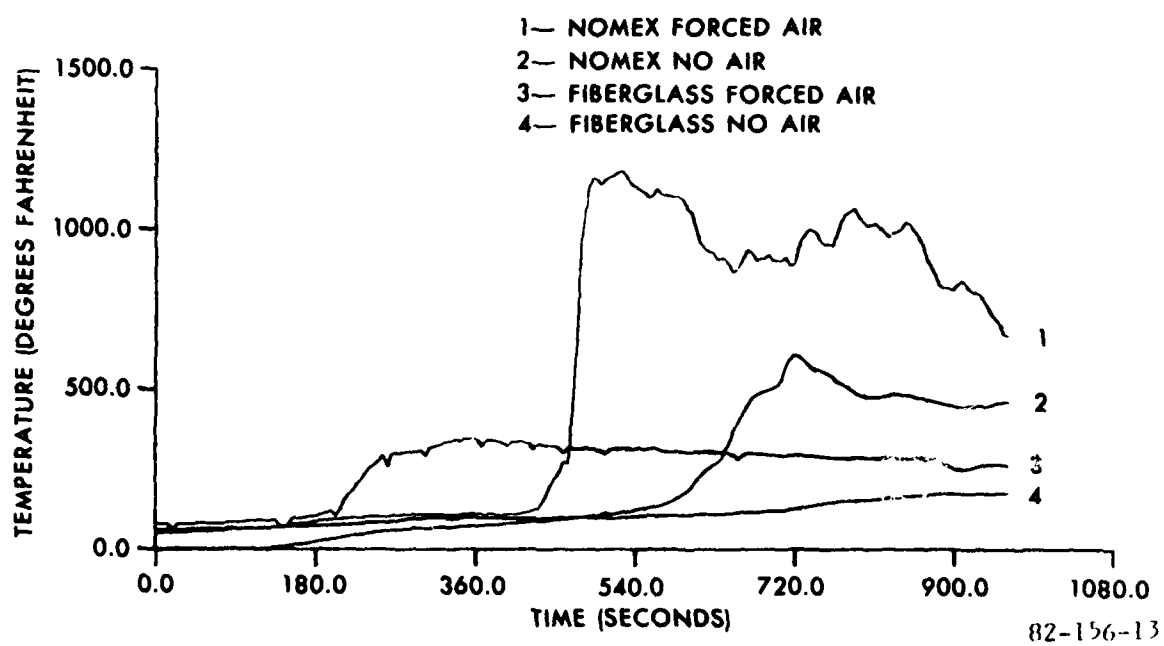
FIGURE 12. ABOVE CEILING TEMPERATURES

700° F above the ceiling as the liner burned away. In test 9, using the fiberglass ceiling liner and without forced ventilation, the temperature above the liner never exceeded 200° F.

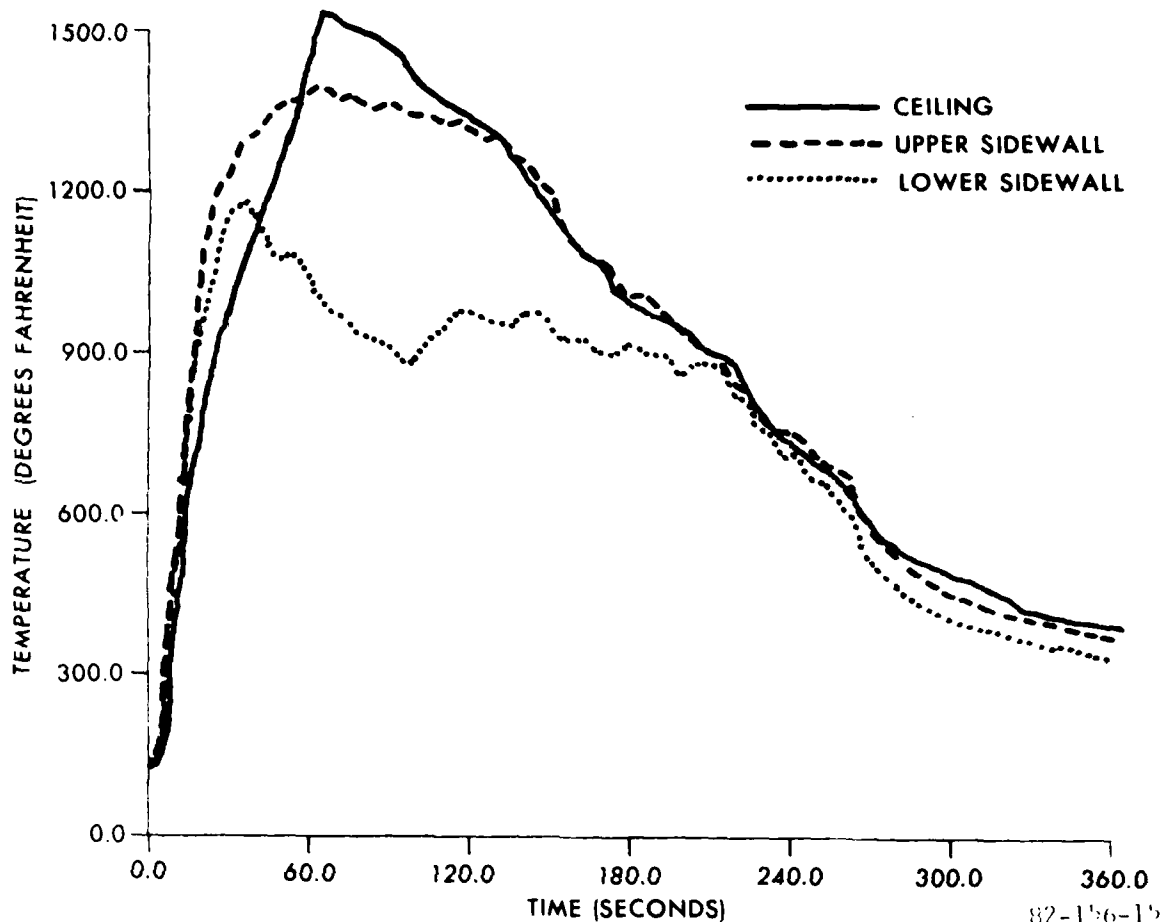
FIGURE 14. TEMPERATURE PROFILE WITH JP4 AS A FIRE SOURCE

The maximum temperature measured by the ceiling thermocouples was in test 10 and was approximately 1700° F. Maximum ceiling temperatures recorded in other tests where the fire developed beyond the initial flare-up were in the range of 1500 to 1700° F. Sidewall temperatures were slightly less. Figure 14 is a plot of the temperature on the ceiling and sidewall resulting from igniting one liter of JP4 in a fire pan. Similar temperatures were recorded when polyurethane seat cushions were ignited in this same pan. Temperatures in 2000- and 5000-cubic foot compartments reached 1800° F as seen in figure 2.

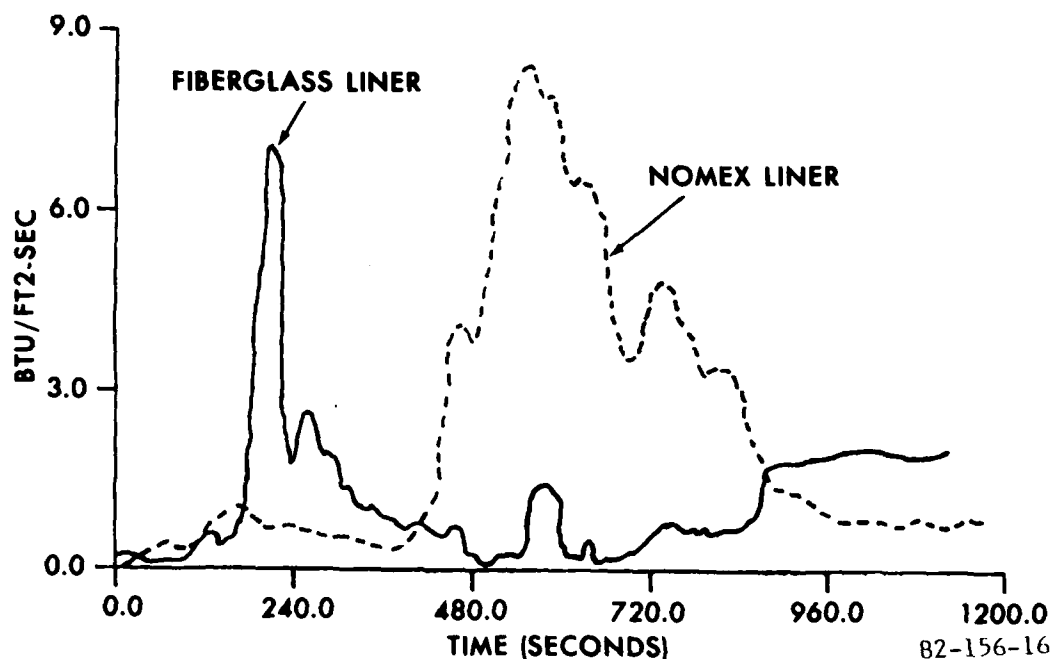
FIGURE 15. HEAT FLUX ON CEILING LINERS

Maximum heat flux levels recorded on the ceiling were in the range of 6.0 to 8.6 BTU/ft²-second for the tests that developed beyond a smoldering condition. Figure 15 shows the heat flux incident on the ceiling liner for test 7 and 10 using fiberglass and Nomex ceiling liners, respectively.
